Remap Newsletter No.78 – June 2018

Derby, Burton & District Panel
Serving Derbyshire & East Staffordshire

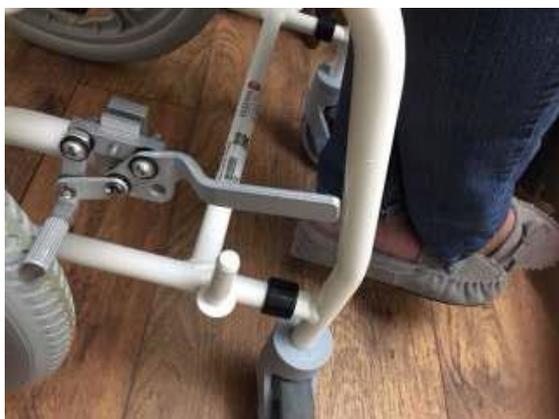
As can be seen, the position and attitude of this elderly MS sufferer's shower chair brakes meant that he found it difficult to reach them and risked over balancing. He had actually fallen out of chair on one occasion.

The shower chair company was contacted but was unable to come up with any workable solutions. The chair belonged to Mediquip so no irreversible modifications could be made to it.

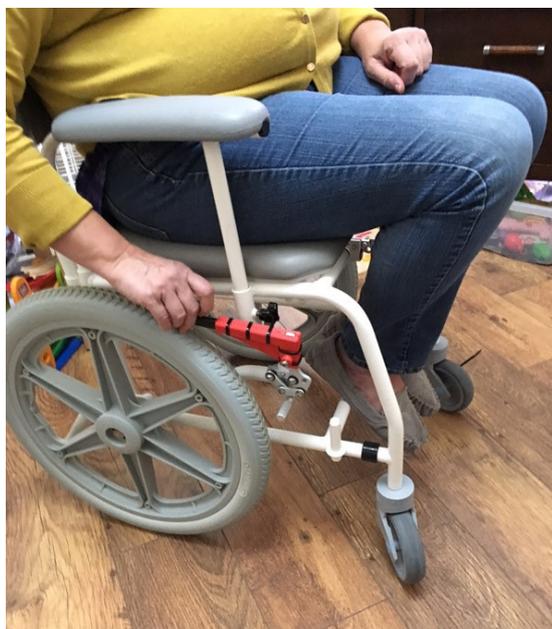
New red plastic brake levers were designed and made by Bernard Kileen using Alibre Design 3D CAD software and printed on a fused deposition 3D printer. The design incorporated a pinch screw, provision for the original cover and embedded strengthening rods.

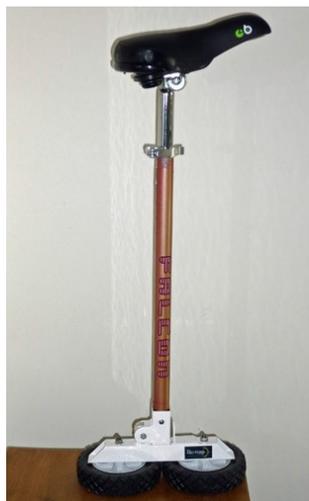
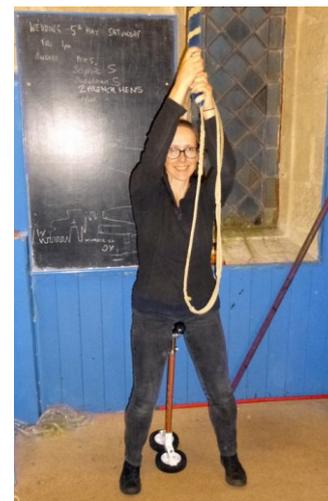
A support was made for her that comprised a lady's cycle saddle adjustably fixed on to the top of a vertical tube which in turn was attached to a base. The base was two horizontal rubber-tired wheels joined by a short steel chassis faced in rubber to grip the floor but was curved to avoid being caught in a rope loop. The vertical tube was fixed on top of the chassis using an offset hinge which allowed the ringer, if necessary, to step backwards away from the rope without lifting the front of the base off the floor and avoided it to being caught in a rope loop.

The saddle was attached so the ringer's centre of gravity lay in a normally stable position in front of the hinge point.

Note that the lady demonstrating the use of the device was the girl's mother as she was too shy.

In the risk assessment, this aid has been classified as "at medium" risk since the ringer must be aware that stepping backwards moves the aid to an unstable position.

Dealing with this situation was an important part of the training sessions. The client was able to cope with this aspect as she was a competent ringer. The operating instructions also detailed the saddle height settings and positioning of the feet for safe operation.

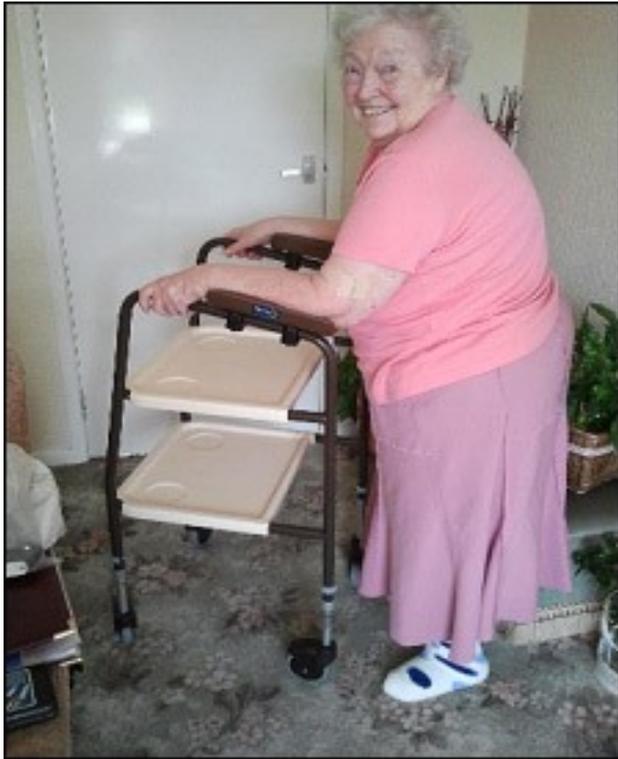
This lady used a kitchen trolley for support as she was unable to stand upright without help. A previous referral – DB-083-17 that was carried out for her resulted in special supports for her arms as she bore down on the trolley frame. However these supports did not last long. Although she found them very comfortable, the way she walked with her weight concentrated on the rear right hand corner of the armrest, caused the plastic liner to crack.

This new referral was made to improve on the previous one. New arm supports were made basically to the original design but with an extended wider rear support steel cradle on which the plastic liners were attached.

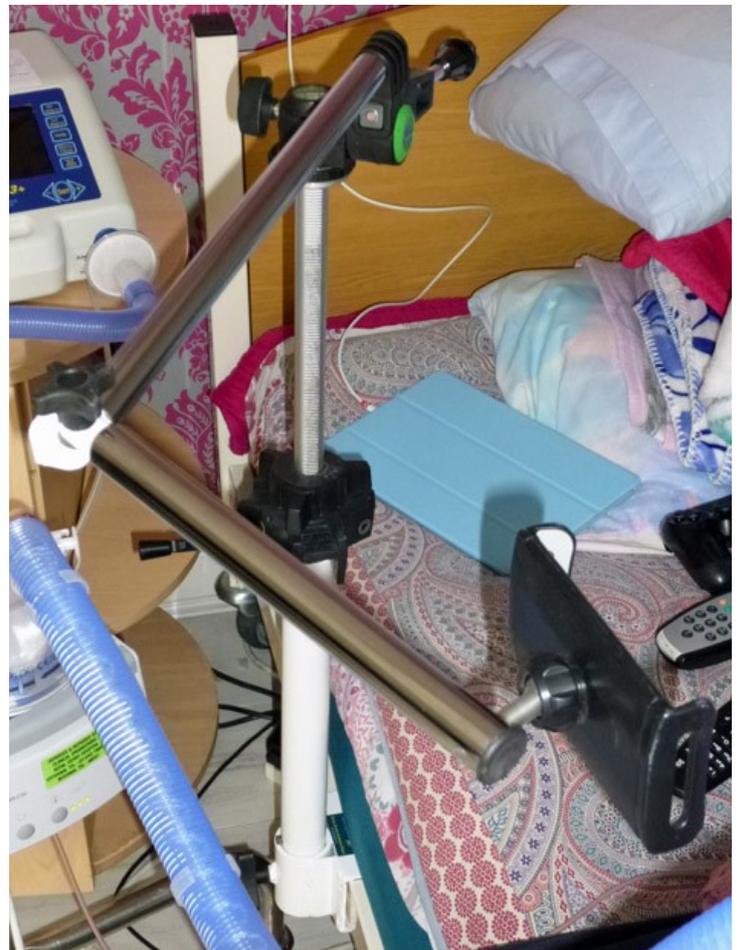
A highly adjustable support was made using an old camera mount as its basis. The legs were removed from the camera mount and replaced by a central tubular column which was supported in a specially made clamp attached to the bed frame. A cranked horizontal arm supported the iPad via a commercially available spring-loaded plastic clamp mounted on an adjustable ball joint.

The arm had adjustment for length and angular position in both the vertical and horizontal planes. The overall height could be adjusted using a winding handle that operated a rack and pinion device within the vertical post.

All settings could be locked in position.

In order to provide easy access when making her bed, the whole assembly could be removed from the bed-mounted clamp by releasing a locking thumb screw.
